**MONTGOMERY COUNTY FIRE/RESCUE SERVICE
POST INCIDENT ANALYSIS**

**19350 Churubusco Lane
March 14, 2016**

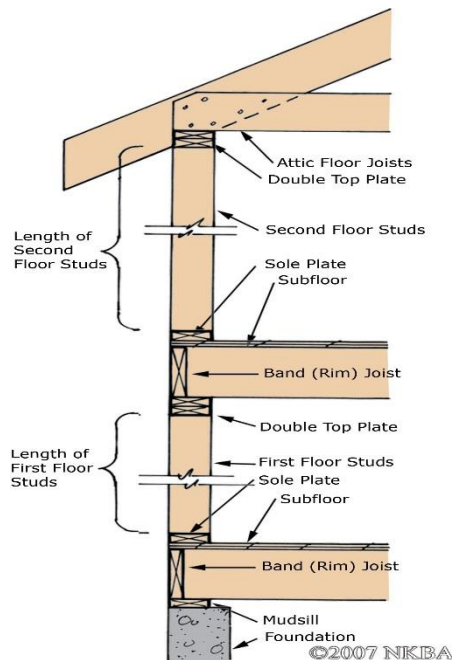
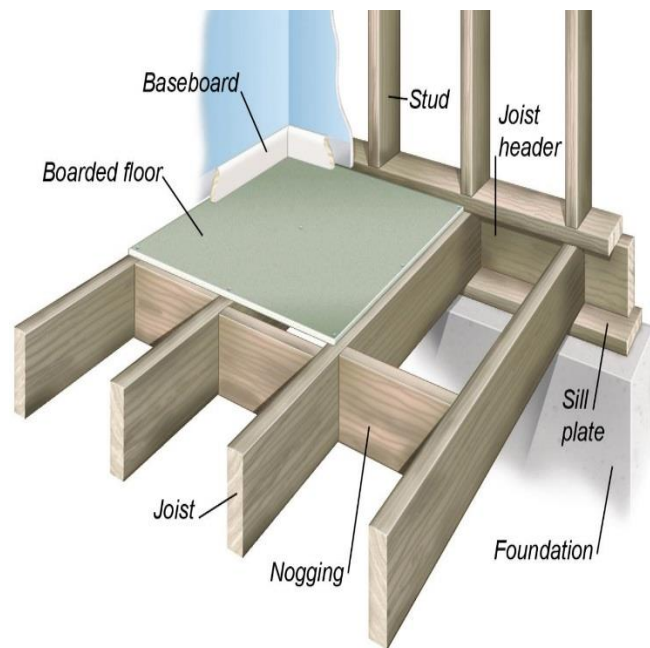
Fire Building - Sill plate with strapping present

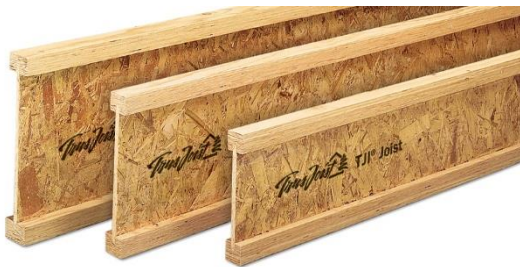
Engineered Floor Joists:

ranges from 10d (3" nail) to a 16d (3 ½" nail) and greatly depends on the size of the upper and bottom flange. An interesting item to note was that several nails were noticed on the front band board of the Churubusco Lane structure with only an average of ¾" embedment through the 2x12 band board and into the floor joist. This could indicate that the nails were smaller than the manufacture recommendations and could also indicate poor attachment of the band board to the joist flange. If poor nail embedment was a legitimate concern, then it could be assumed that the likelihood of the band board pulling away from the floor joist would increase at a time when the structure is significantly compromised. The image below shows where a pre-existing floor joist were "toe" nailed into the sill plate

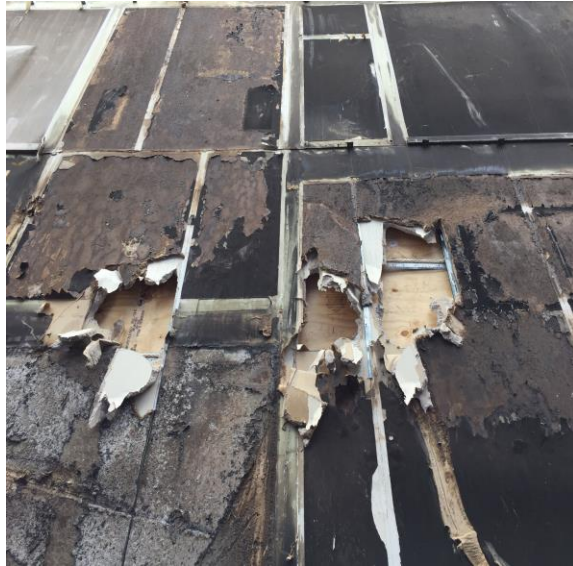
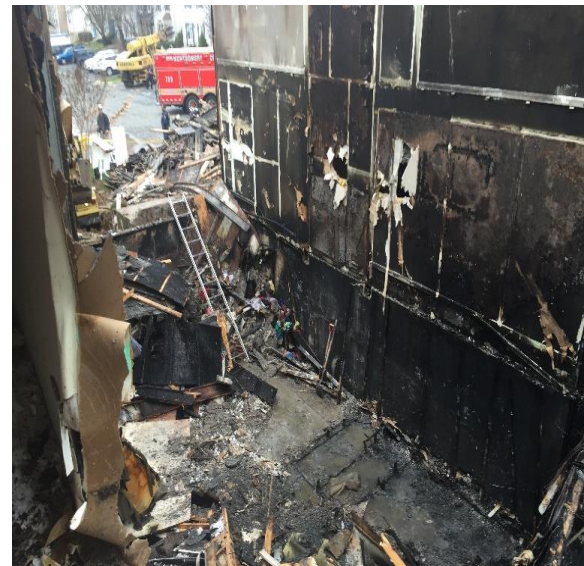
Fire Wall:

The townhouse units in this development were constructed with full length fire wall separation. This system was constructed by use of double 5/8 inch gypsum fire rated wall panels. Metal studs were utilized to aid in the capability of preventing fire extension to the exposures. In the case of this fire, the fire wall remained intact and appeared to have functioned as designed. The fire extension noted in the adjacent structures were minimal given the volume of fire encountered. It is likely that the fire extension that did occur was due to exterior spread and not due to a breach in the fire wall system. It should be noted that several areas were exposed by fire personnel in an effort to suppress the volume of fire in the main structure. There were areas of fire extension noted however they seemed to be isolated to areas which were not protected by the fire wall. This was due to the "off set" style of construction seen throughout the row of these townhomes.
